CARS

13V-314  
(5 pages)

**Subject: Part 573 Recall Notice – Lotus Cars Limited**

**Defect Information Report**

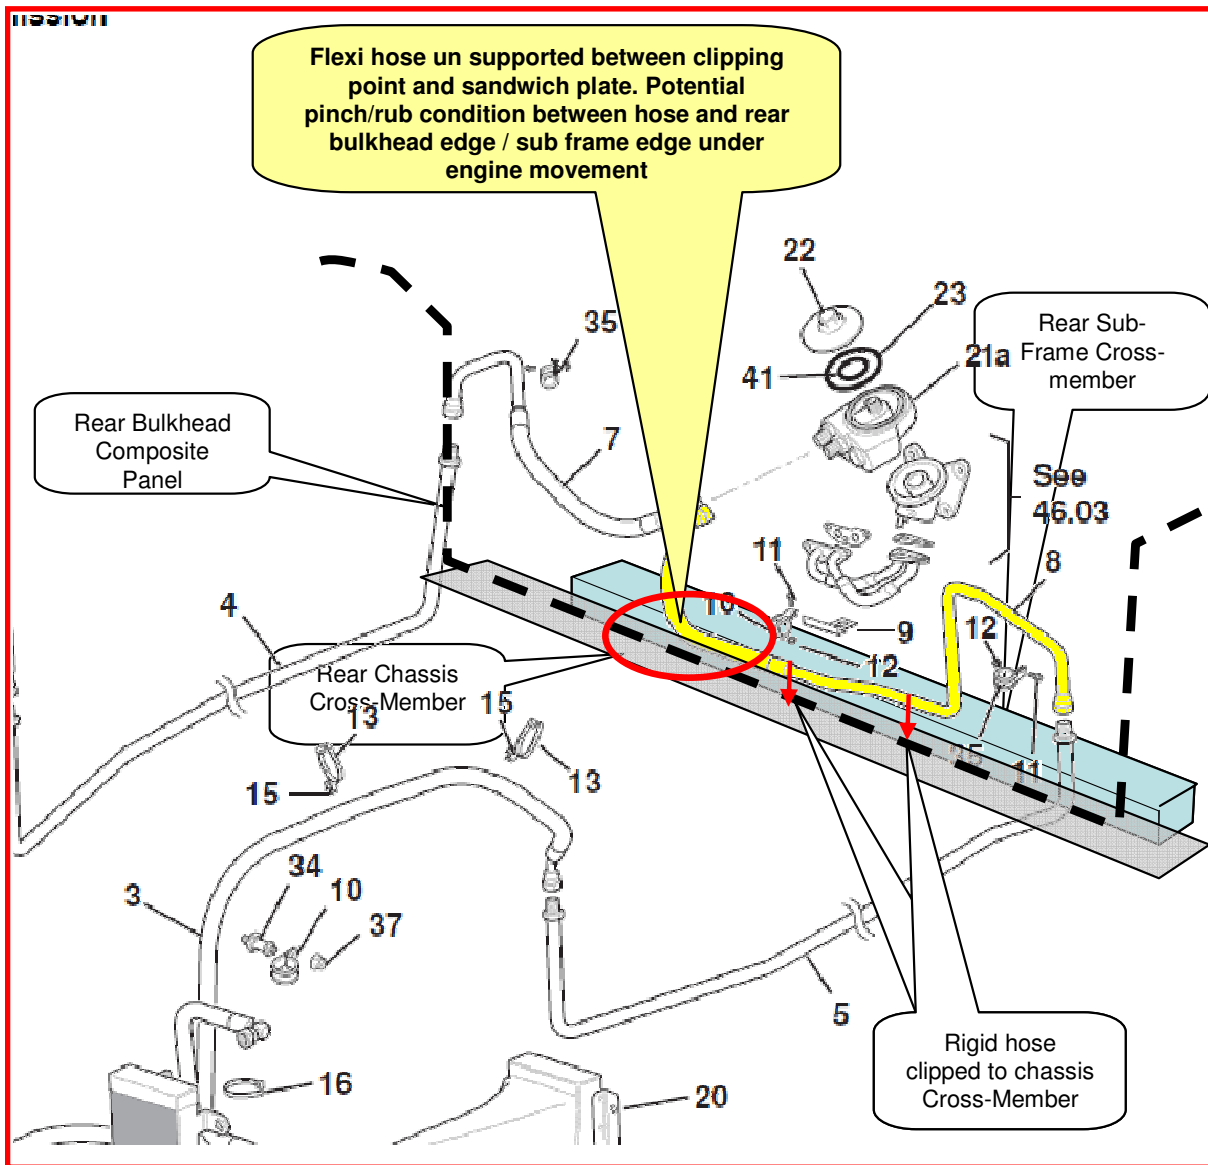
**OIL COOLER HOSE ASSEMBLY**

Vehicles affected are 2011 model year Lotus Evora supercharged, manual gearbox cars. Affected vehicles have been built with a flexible oil hose that could chafe against a chassis bulkhead, increasing the risk of hose rupture.

There have been two incidents where an engine oil cooler hose has ruptured resulting in oil loss. A lack of clearance between the hose and the edge of a

composite bulkhead may result in abrasion to the hose due to the natural movement of the engine.

It has been established that in the event of hose failure, engine oil may be ejected onto the road surface and/or rear wheels which could cause a reduction in vehicle control and potential engine failure. There may also be a loss of oil into the engine bay area resulting in an increased risk of fire.

The pipe in question is a Lotus designed part, manufactured by Delta Aircraft Services and is used exclusively on Evora supercharged, manual gearbox variants. The part is now obsolete following a system design change implemented with the introduction of the Evora auto gearbox variant.
